SonaVu™ Ultrasonic Acoustic Imaging Camera

SonaVu™ Ultrasonic Acoustic Imaging Camera for Compressed Air Leak Management

SonaVu™ Ultrasonic Acoustic Imaging Camera for Electrical Asset Reliability

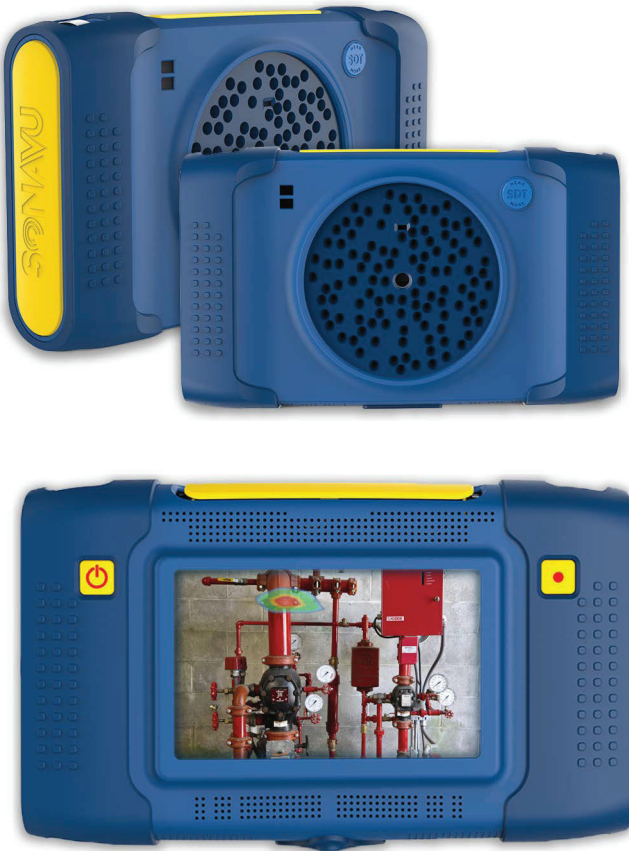
SonaVu™ is a multi-frequency acoustic camera that takes airborne ultrasound inspection to a new level. Equipped with 112 highly sensitive sonic sensors and a precision optical camera, SonaVu™ brings the power of super-human hearing to focus on its vibrant, color touch screen. It unlocks limitless applications for asset reliability, energy conservation, and safety including compressed air leak management, electrical asset reliability, tightness control of large volumes, and much more.

A simple leak detection procedure consists of picking up the SonaVu™ and powering it on. Connect the high-quality noise attenuating headphones so you can hear what SonaVu™ hears. Then simply point the acoustic sensor array towards any compressed air lines. Listen for the characteristic hissing of the air leaks in the headphones and watch the color display light up with the precise location of the leak.

All controls are found on the SonaVu™ touch screen.

1. Set the distance:

- Choose near range (<5m) or far range (>5m) or auto range to let SonaVu™ decide.

2. Set the frequency:

- For compressed air leaks choose 25-40kHz

3. Set the gain

- Difference between min/max sound pressure.

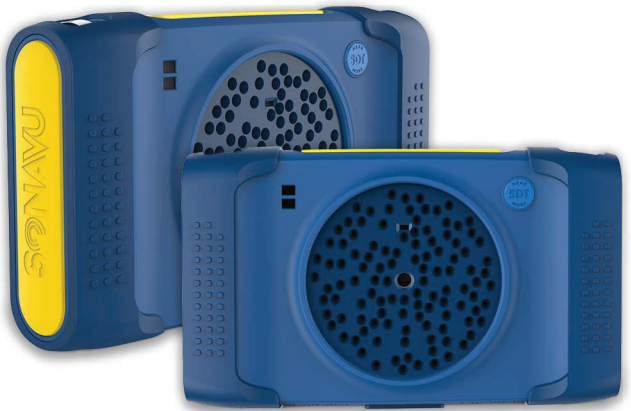
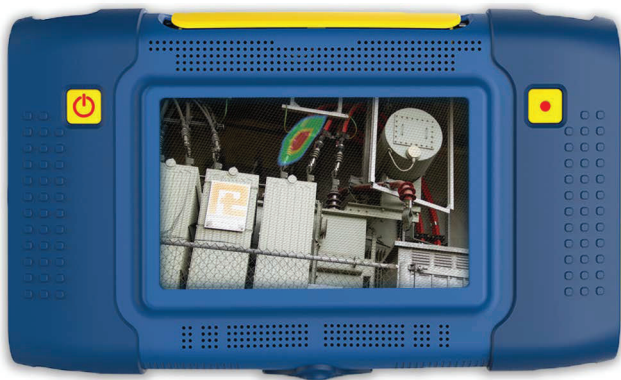
Partial Discharge Testing with an Acoustic Imaging Camera | SonaVu™

The procedure for scanning is straightforward. Connect the noise attenuating headphones to the SonaVu™ and position the sensors towards potential sources. The ultrasound produced by partial discharge excites the sensors while their location is revealed on the display. Tap the icon to capture either a video or still image to place it into your inspection report. It's that easy!

Sources of ultrasound created by the presence of partial discharge are superimposed on the image allowing inspectors to intuitively pinpoint their location.
